Inspection Report

Minerals Regulatory Program

Mine Name: Three Mile 1
Operator Name: Mike Dettamanti

Permit number: S/025/013
Inspection Date: August 3, 2005
Time: 10:00

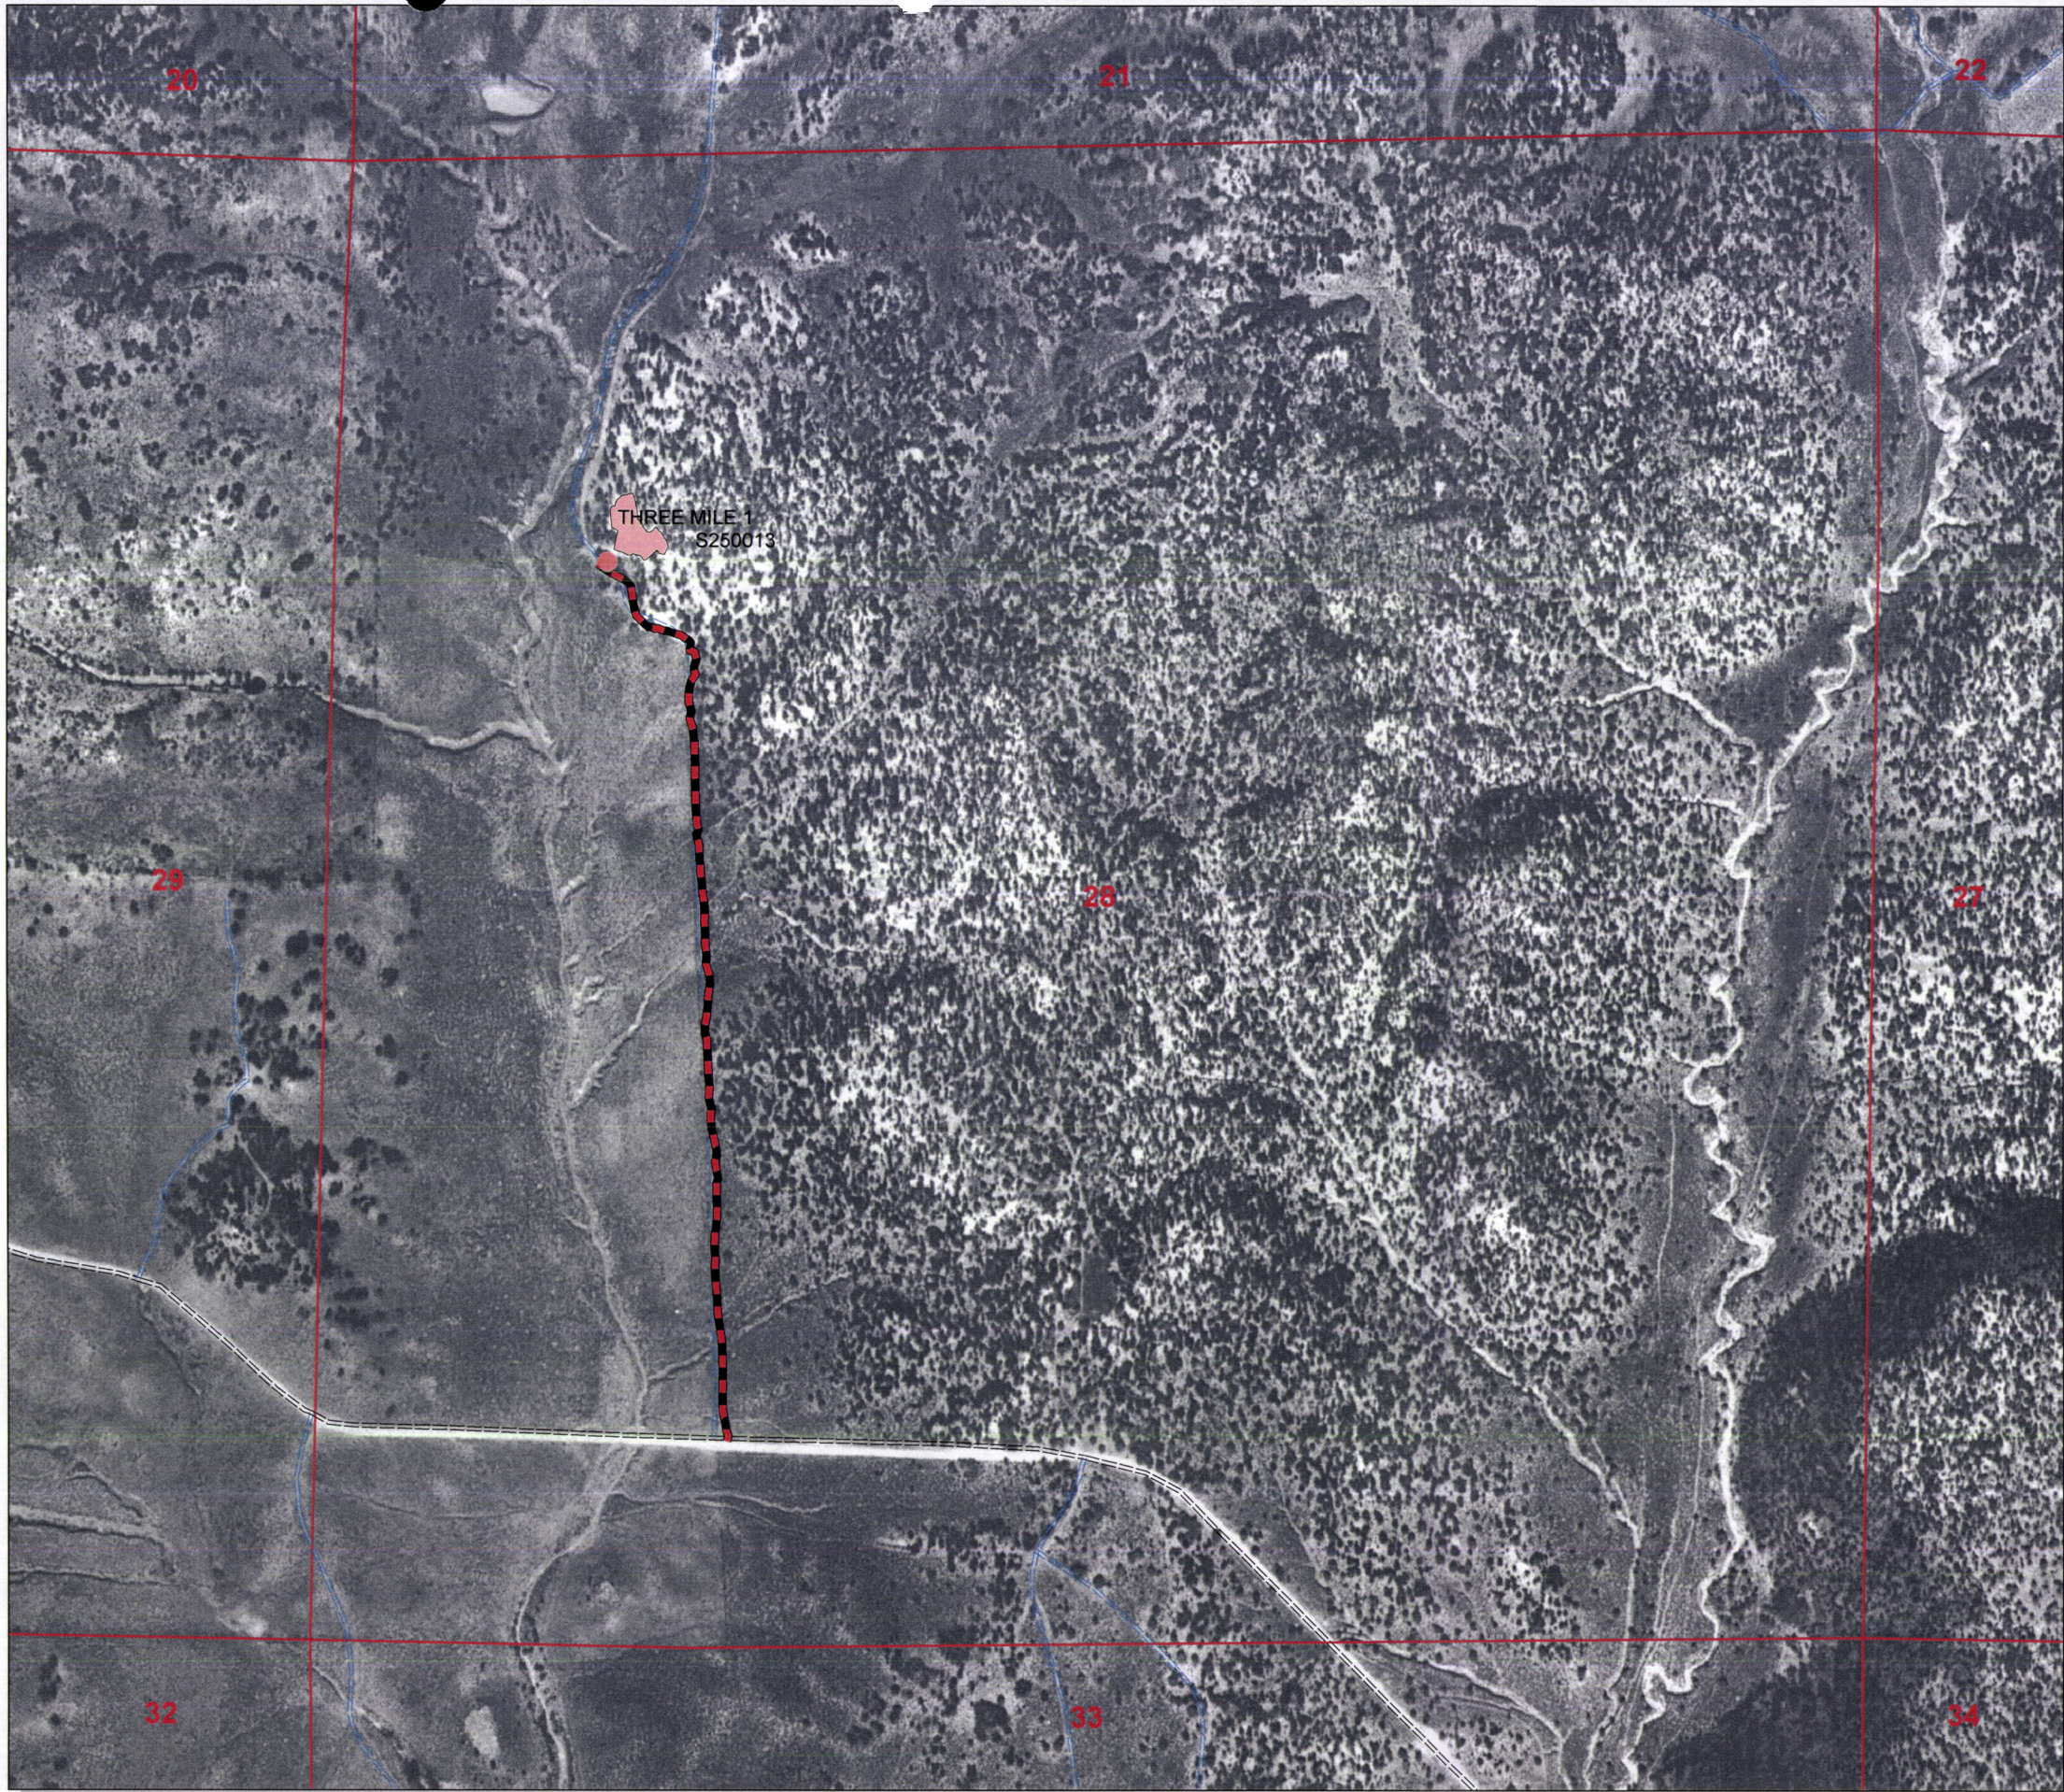
Mine Number: S250013
Mine Name: Three Mile #1
Township 40 S Range 06 W
Section 28 SLBM

The disturbance at the site was GPS'd which reflects a total disturbance of 0.59 acres. There is two small disturbances at the site. Neither of the areas was recontoured before the operator left the site.

Acres Disturbed	0.59
Acres Regraded	0
Acres Seeded	0
